SUMMARY
24831 Richmond St, Dearborn, MI
48124
Bryan Blackburn
08/03/2023

Summary of Property Inspection Report

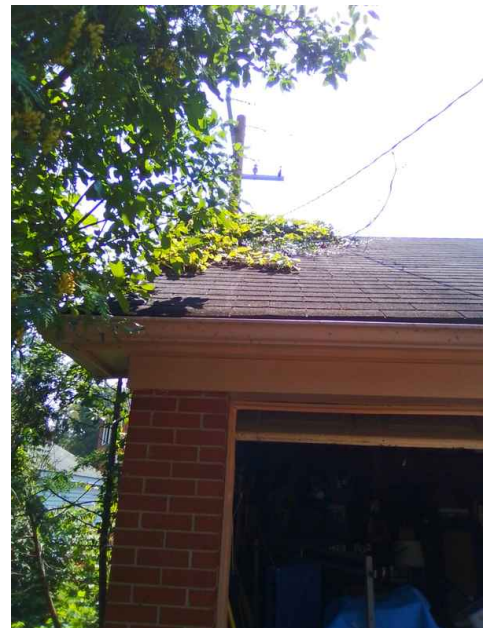
GARAGE ROOF

TREE DEBRIS ON ROOF

Tree debris observed on roof. This can cause improper drainage to gutters and downspouts. Recommend clearing debris.

Over grown vegetation from neighbors yard.

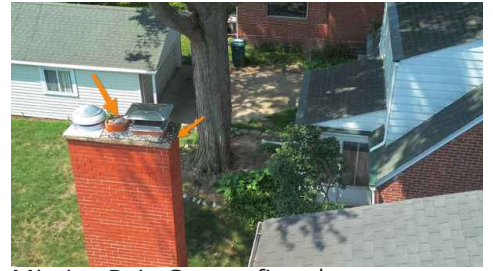
BACK ADDITION FIREPLACE

CHIMNEY RAIN CAP MISSING

I observed a missing chimney rain cap. The rain cap covers the top opening of the chimney flue liner. The cap is missing for the stove exhaust built into the fireplace. Also shown in the photo, recommended mortar tuck and point.

Missing Rain Cap on fire place stove exhaust. Should be properly covered. Recommend point and tuck mortar repair.
