Somewhere in  
Michigan

AOM Property Inspection  
Solutions Sample Report

Single  
Family (2  
story)

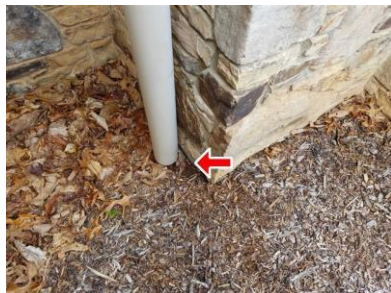
1.3 Item 1 (Picture)

Drain line has sunken or pulled loose from downspout. This area needs repair.

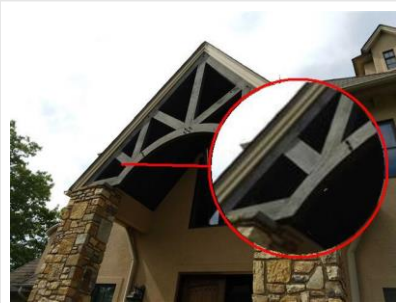
2.0 Item 1 (Picture)

- (1) The stucco siding, trim and fascia are in need of cleaning and repainting throughout. Gutters will need to be temporarily removed to paint and then re-install.
- (2) The gable wood work on at least two locations shows signs of some damage from carpenter bees etc. and needs repair and prep and paint.
- (3) Some repair areas noticed

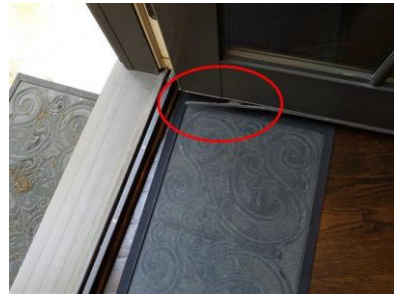
2.1 Item 1 (Picture)  
balcony from kitchen

(1) Weather stripping on a few exterior doors are loose, missing or damaged in areas..

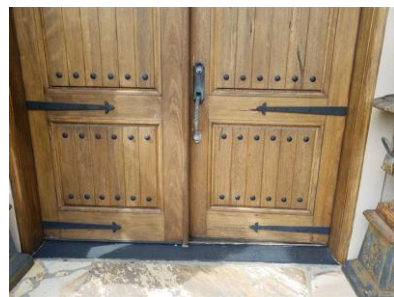
2.1 Item 3 (Picture)

(2) Stain used to protect main doors has faded or failed and need prep and stain again.

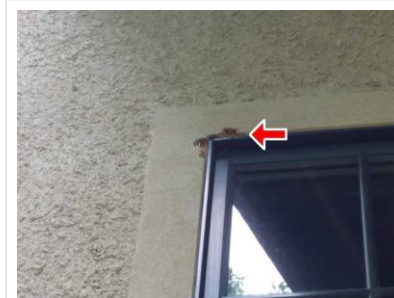
2.2 Item 1 (Picture)

Window trim is damaged at the rear of home over the extra room (seen from ground level).

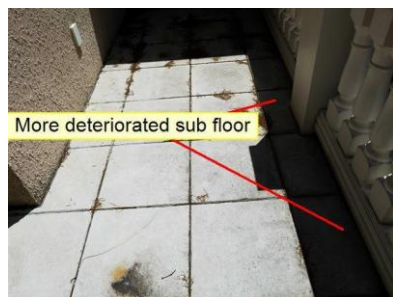
2.3 Item 1 (Picture)

(1) The master suite balcony floor is deteriorated. Water has come in along front or outer band where tile or trim failed to cover seam when installed. Tile is cracked in an area. Guard rail and tile will need to be replaced. Guard rail can be re used but tile likely cannot. Subfloor will need to be replaced along front length of balcony and side nearest door and install tile and seal.

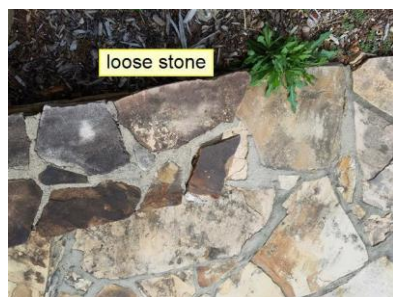
2.3 Item 4 (Picture)

(2) Loose stone at steps of home at entry.

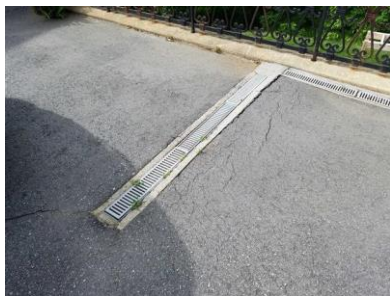
2.4 Item 1 (Picture)

(1) Driveway does not drain water and an attempt to correct with trench drains is not par with the expectations of this home and does not appear to work. Uneven or sag in areas. A proper repair is to remove pavement, slope correctly and apply new pavement.

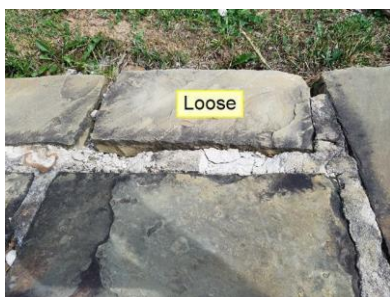
2.4 Item 3 (Picture)

(2) Reattaining wall has at least one loose stone and some areas need grout again and sealant applied.

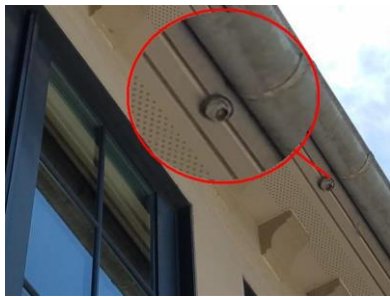
2.5 Item 1 (Picture)

- (1) See Wall Cladding comments involving the need to prep and paint to protect.
- (2) Hornets nest "active" and is quickly forming above balcony.

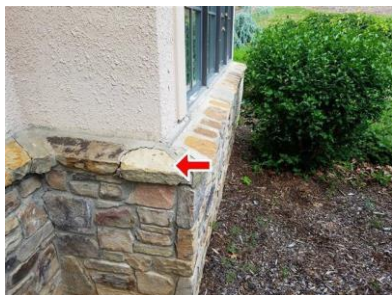
3.1 Item 1 (Picture)

Rock wall has settled or continues to settle and repair signs indicate it has settled previously and has settled more or again. Repairs are needed to wall and cement chinking. See roof section at Gutters and downspouts for more repair recommendations.

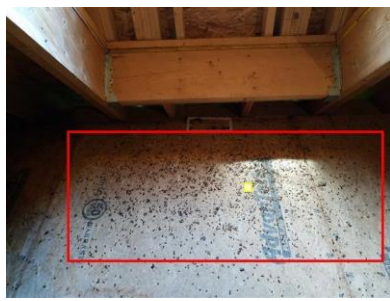
3.5 Item 1 (Picture)

Insects dead from entering around window area in attic (FYI).

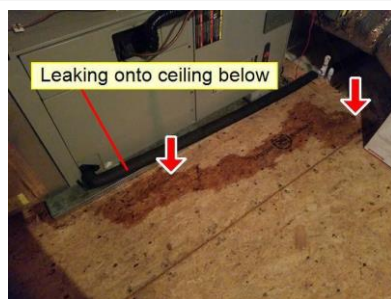
4.0 Item 1 (Picture)

Air handler was leaking condensation into the drain pan. The drain pan was full and eventually the safety switch did cut off unit. However it still leaked which could mean that the pan itself may leak at a seam? Note: The listing agent called a HVAC person who did replace the filter that was clogged and troubleshooted the system. I did not see if he removed the standing water. Not doing so can cause more to leak onto the ceiling below. The ceiling below was dripping water and has already stained. I did not inspect for mold and it could develop. Repairs if air handler was repaired will likely be prime seal ceiling and re paint.

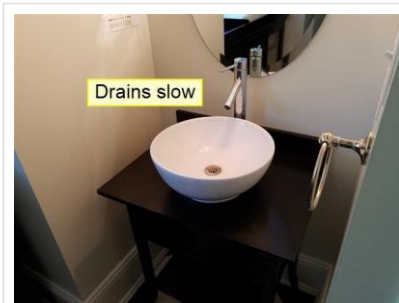
5.0 Item 1 (Picture)

(1) Both sinks in shared bathroom upstairs drains slow.

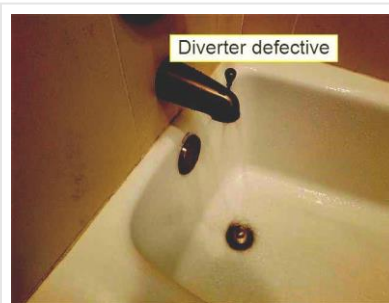
5.0 Item 2 (Picture)

(2) The diverter on tub spout does not divert all water from tub to shower enough to affect the flow.

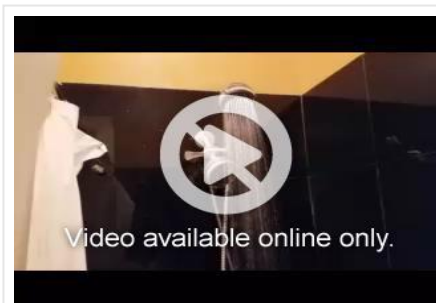
5.1 Item 1 (Video)

(1) Shower fixture leaked in a few areas where seals may be old. Recommend repair or replace as necessary.

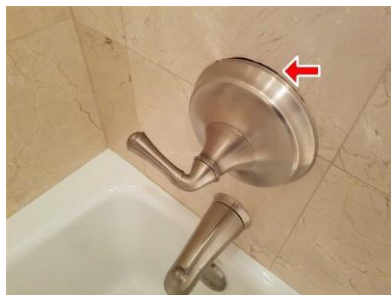
5.1 Item 3 (Picture)

(3) Protective cover for fixture has sagged or loosened to where water can get in behind wall at light blue guest bedroom upstairs and at master shower,

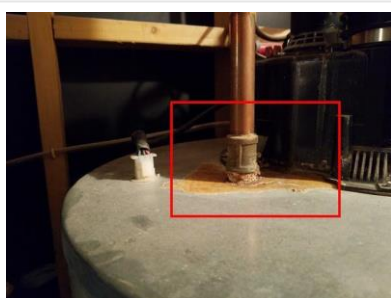
5.2 Item 1 (Picture)

Water connection to water heater leaks or has corroded and may have temporarily stopped leaking due to corrosion? A plumber should repair or replace as needed.

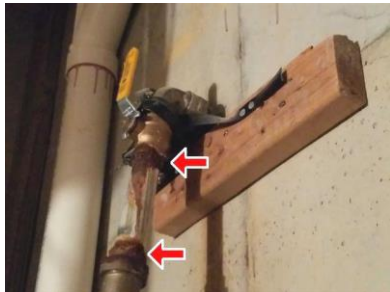
5.3 Item 1 (Picture)

Main water has leaked or leaking at connection. Drip stains seen on replacement filters for HVAC being stored below. This is a high pressure area and needs connection fittings replaced. Line could rupture or become worse. A plumber should replace.

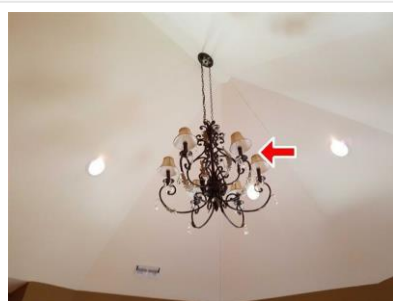
6.3 Item 1 (Picture)

I was unable to see the light fixture work or come on in the upstairs Master? It could be that all bulbs are burned out or it may require an electrician.

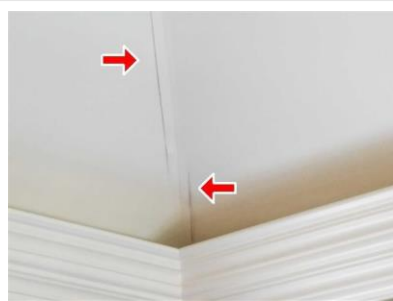
8.0 Item 1 (Picture)

Tape used to bed Gypsum board seams are loose, failed in a few areas of home including 4 corners of highest ceiling as well as Master bedroom upstairs. Work will require painting all ceiling to match. Due to the height this will require a means to access the area, and can increase the cost to repair.

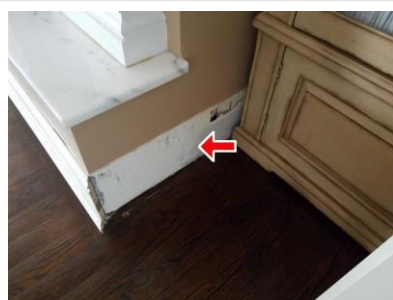
8.1 Item 1 (Picture)

Baseboard and trim missing from both sides of fireplace in Master bedroom.

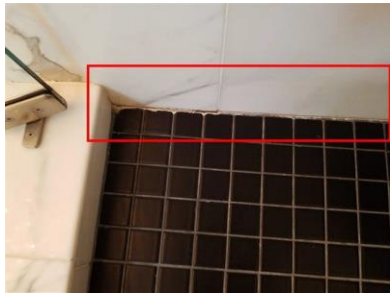
8.2 Item 1 (Picture)

Tile floor in Master needs grout where missing and reseal.

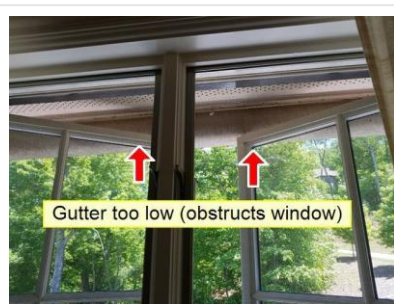
8.6 Item 1 (Picture)

(1) Double window cannot open fully due to the gutter being too low at shared bathroom upstairs.

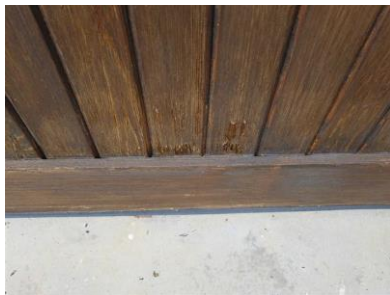
9.3 Item 1 (Picture)

All three garage doors are no longer protected by the stain or sealant and are starting to peel, fade and eventually deteriorate.

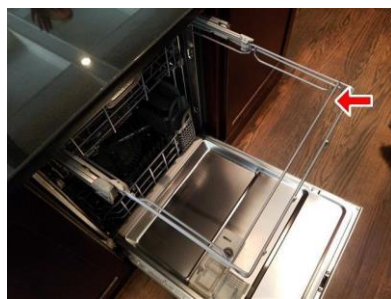
10.0 Item 1 (Picture)

It appears that the silverware tray is missing?

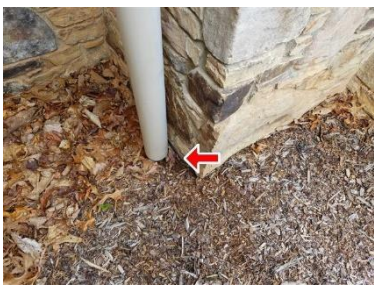
1.3 Item 1 (Picture)

Drain line has sunken or pulled loose from downspout. This area needs repair.

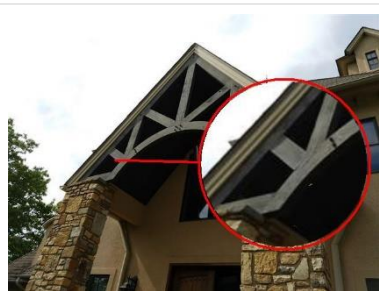
2.0 Item 1 (Picture)

(2) The gable wood work on at least two locations shows signs of some damage from carpenter bees etc. and need repair and prep and paint.

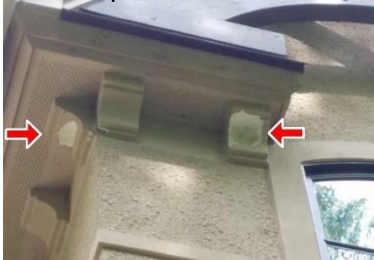
2.0 Item 2 (Picture)

(4) Some repair areas noticed:

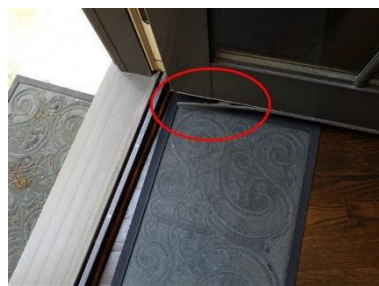
2.1 Item 1 (Picture)  
balcony from kitchen

- (1) Weather stripping on a few exterior doors are loose, missing or damaged in areas..

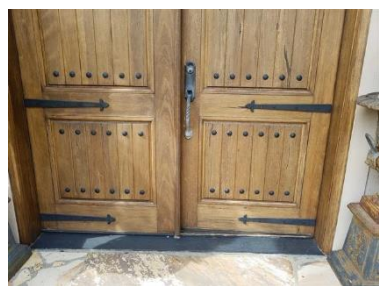
2.1 Item 3 (Picture)

- (2) Stain used to protect main doors has faded or failed, and need prep and stain again.

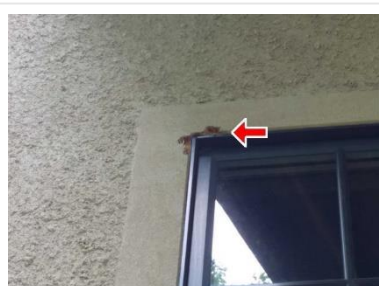
2.2 Item 1 (Picture)

Window trim is damaged at the rear of home over the extra room (seen from ground level).

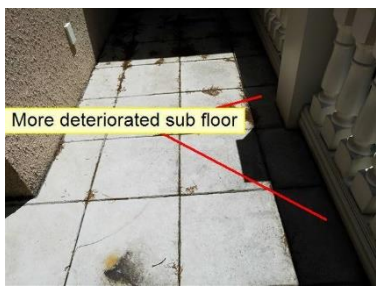
2.3 Item 1 (Picture)

(1) The master suite balcony floor is deteriorated. Water has come in along front or outer band where tile or trim failed to cover seam when installed. Tile is cracked in an area. Guard rail and tile will need to be replaced. Guard rail can be re used but tile likely cannot. Subfloor will need to be replaced along front length of balcony and side nearest door and install tile and seal.

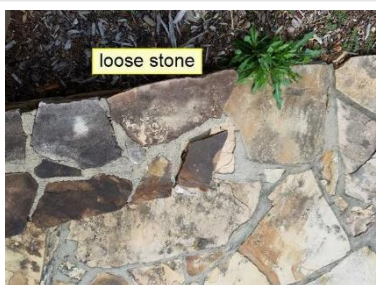
2.3 Item 4 (Picture)

(2) Loose stone at steps of home at entry.

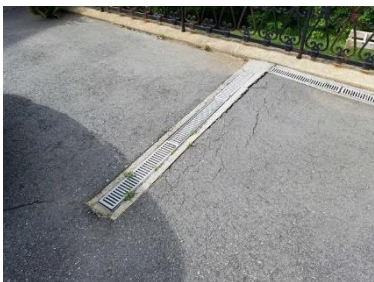
2.4 Item 1 (Picture)

(1) The driveway does not drain water and an attempt to correct with trench drains is not par with the expectations of this home and does not appear to work. Uneven or sag in areas. A proper repair is to remove pavement, slope correctly and apply new pavement.

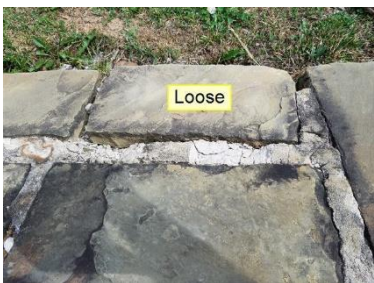
2.4 Item 3 (Picture)

(2) Reattaining wall has at least one loose stone and some areas need grout again and sealant applied.

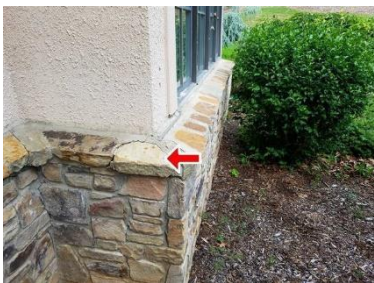
3.1 Item 1 (Picture)

Rock wall has settled or continues to settle and repair signs indicate it has settled previously and has settled more or again. Repairs are needed to wall and cement chinking. See roof section at Gutters and downspouts for more repair recommendations.

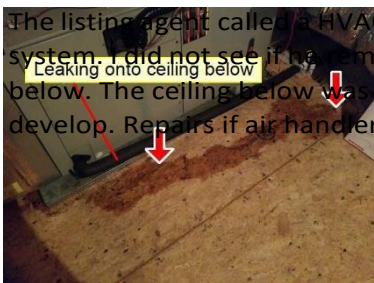
4.0 Item 1 (Picture) Somewhere in Michigan

Air handler was leaking condensation into the drain pan. The drain pan was full and eventually the safety switch did cut off unit. However it still leaked which could mean that the pan itself may leak at a seam? Note: The listing agent called a HVAC person who did replace the filter that was clogged and troubleshooted the system. I did not see if he removed the standing water. Not doing so can cause more to leak onto the ceiling below. The ceiling below was dripping water and has already stained. I did not inspect for mold and it could develop. Repairs if air handler was repaired will likely be prime seal ceiling and re paint.

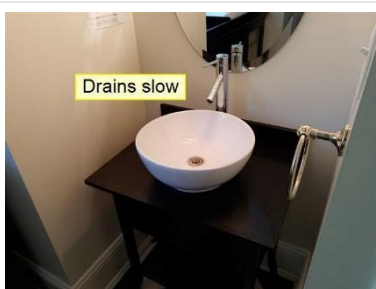
5.0 Item 1 (Picture)

- (1) Both sinks in shared bathroom upstairs drains slow.

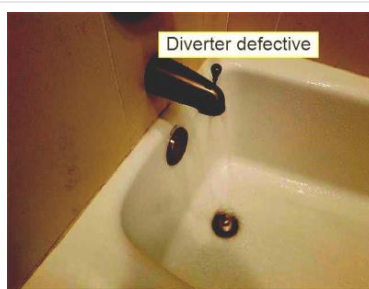
5.0 Item 2 (Picture)

- (2) The diverter on tub spout does not divert all water from tub to shower enough to affect the flow.

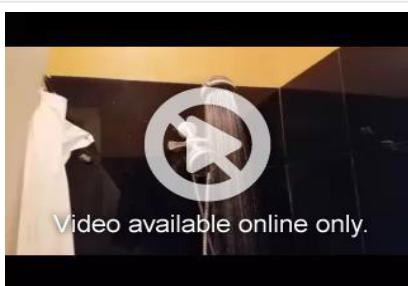
5.1 Item 1 (Video)

- (1) Shower fixture leaked in a few areas where seals may be old. Recommend repair or replace as necessary.

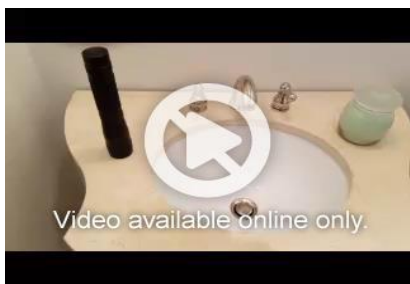
**5.1 Item 2 (Video)**

- (2) Control knobs for guest bath sink upstairs (light blue room) appear to be installed opposite to normal direction to turn water off and on. Volume or pressure here is somewhat low compared to the other plumbing locations in the home.

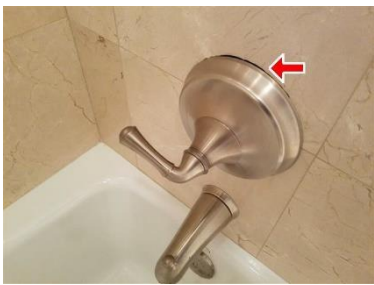
**5.1 Item 3 (Picture)**

(3) Protective cover for fixture has sagged or loosened to where water can get in behind wall at light blue guest bedroom upstairs and at master shower,

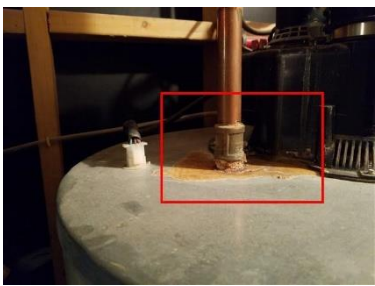
5.2 Item 1 (Picture)

Water connection to water heater leaks or has corroded and may have temporarily stopped leaking due to corrosion? A plumber should repair or replace as needed.

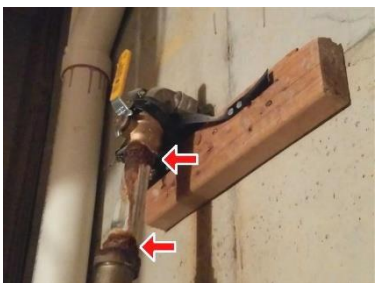
5.3 Item 1 (Picture)

Main water has leaked or leaking at connection. Drip stains seen on replacement filters for HVAC being stored below. This is a high pressure area and needs connection fittings replaced. Line could rupture or become worse. A plumber should replace.

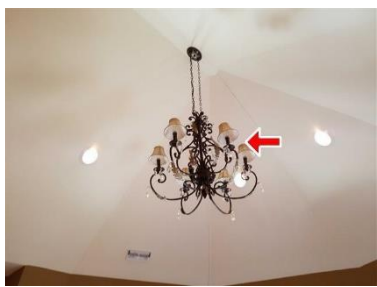
6.3 Item 1 (Picture)

I was unable to see the light fixture work or come on in the upstairs Master? It could be that all bulbs are burned out or it may require an electrician.

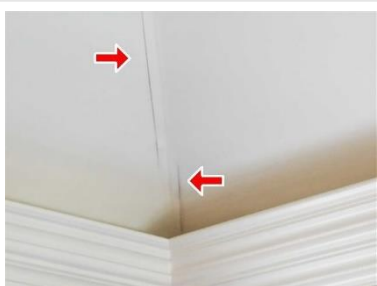
8.0 Item 1 (Picture)

Tape used to bed Gypsum board seams are loose, failed in a few areas of home including 4 corners of highest ceiling as well as Master bedroom upstairs. Work will require painting all ceiling to match. Due to the height this will require a means to access the area, and can increase the cost to repair.

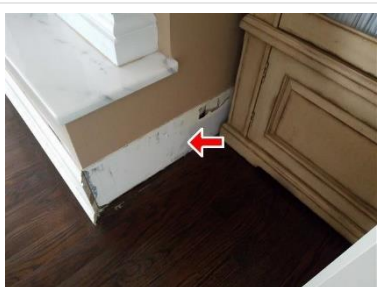
8.1 Item 1 (Picture)

Baseboard and trim missing from both sides of fireplace in Master bedroom.

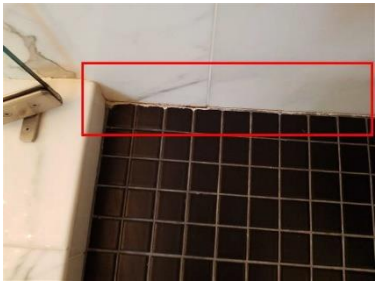
8.2 Item 1 (Picture)

Tile floor in Master needs grout where missing and reseal.

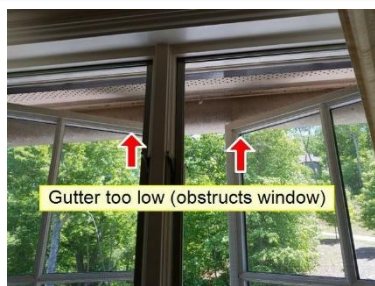
8.6 Item 1 (Picture)

- (1) Double window cannot open fully due to the gutter being too low at shared bathroom upstairs.

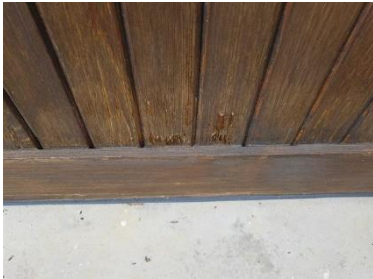
9.3 Item 1 (Picture)

All three garage doors are no longer protected by the stain or sealant and are starting to peel, fade and eventually deteriorate.

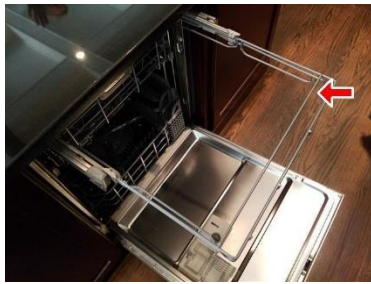
10.0 Item 1 (Picture)

It appears that the silverware tray is missing?
