AOM PROPERTY INSPECTION SOLUTIONS HOME INSPECTION REPORT

24831 Richmond St
Dearborn, MI 48124

Bryan Blackburn
08/03/2023

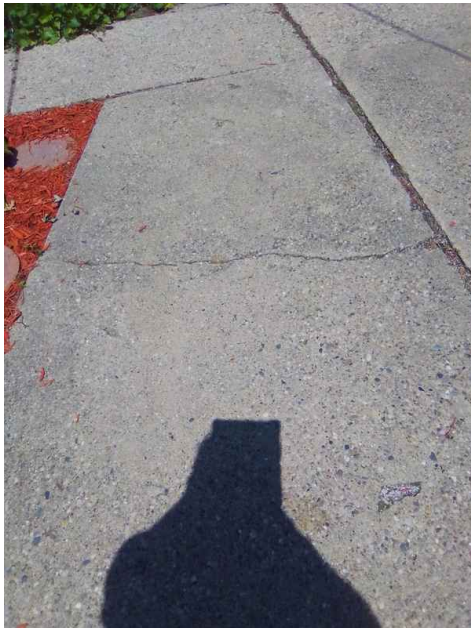
DRIVEWAY: MINOR CRACKING

I observed indications of minor cracking at the driveway. Correction and further evaluation is recommended.

Simple cracks that can be easily filled in with a concrete tube

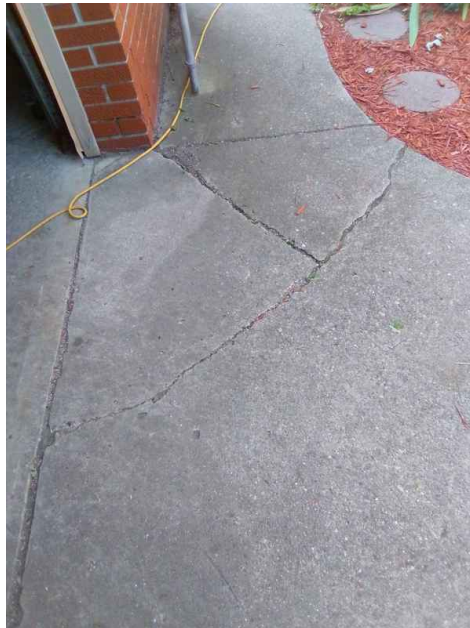
Simple cracks by entrance of garage they can easily be repaired with simple concrete caulking

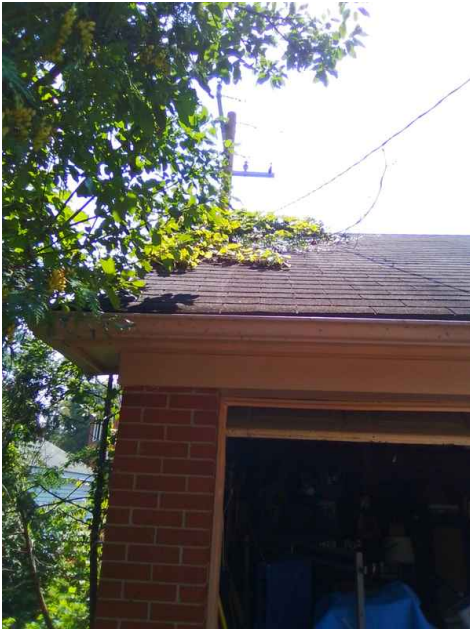
Tree debris observed on roof. This can cause improper drainage to gutters and downspouts. Recommend clearing debris.

Over grown vegetation from neighbors yard.

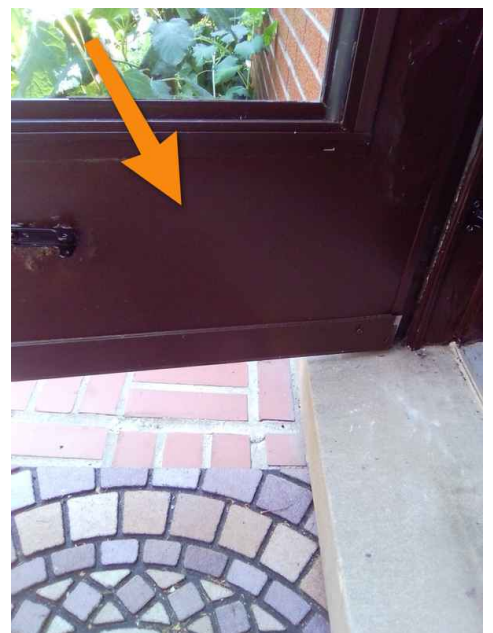
SCREEN DOOR DEFECT

I observed a defect at the screen door.

Missing pneumatic cylinder closing mechanism

Correction and further evaluation is recommended.

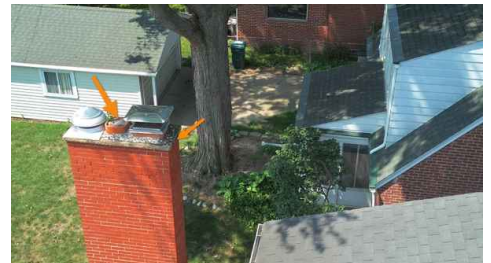
CHIMNEY RAIN CAP MISSING

I observed a missing chimney rain cap. The rain cap covers the top opening of the chimney flue liner. The cap is missing for the stove exhaust built into the fireplace. Also shown in the photo, recommended mortar tuck and point.

Missing Rain Cap on fire place stove exhaust. Should be properly covered. Recommend point and tuck mortar repair.

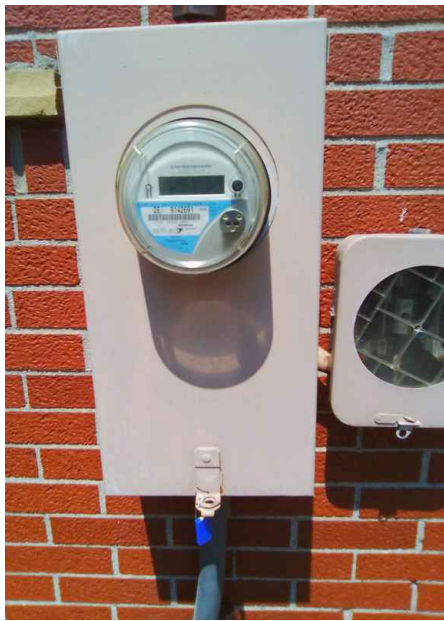
Back of home South East corner

I inspected the electrical electric meter and base.

240 volt service
